Job #08-207-P

April 16, 2008

GEOLOGIC RECONNAISSANCE REPORT, 10-ACRE HILLSIDE PROPERTY (APN 239-360-08) PUEBLA STREET, ESCONDIDO, COUNTY OF SAN DIEGO

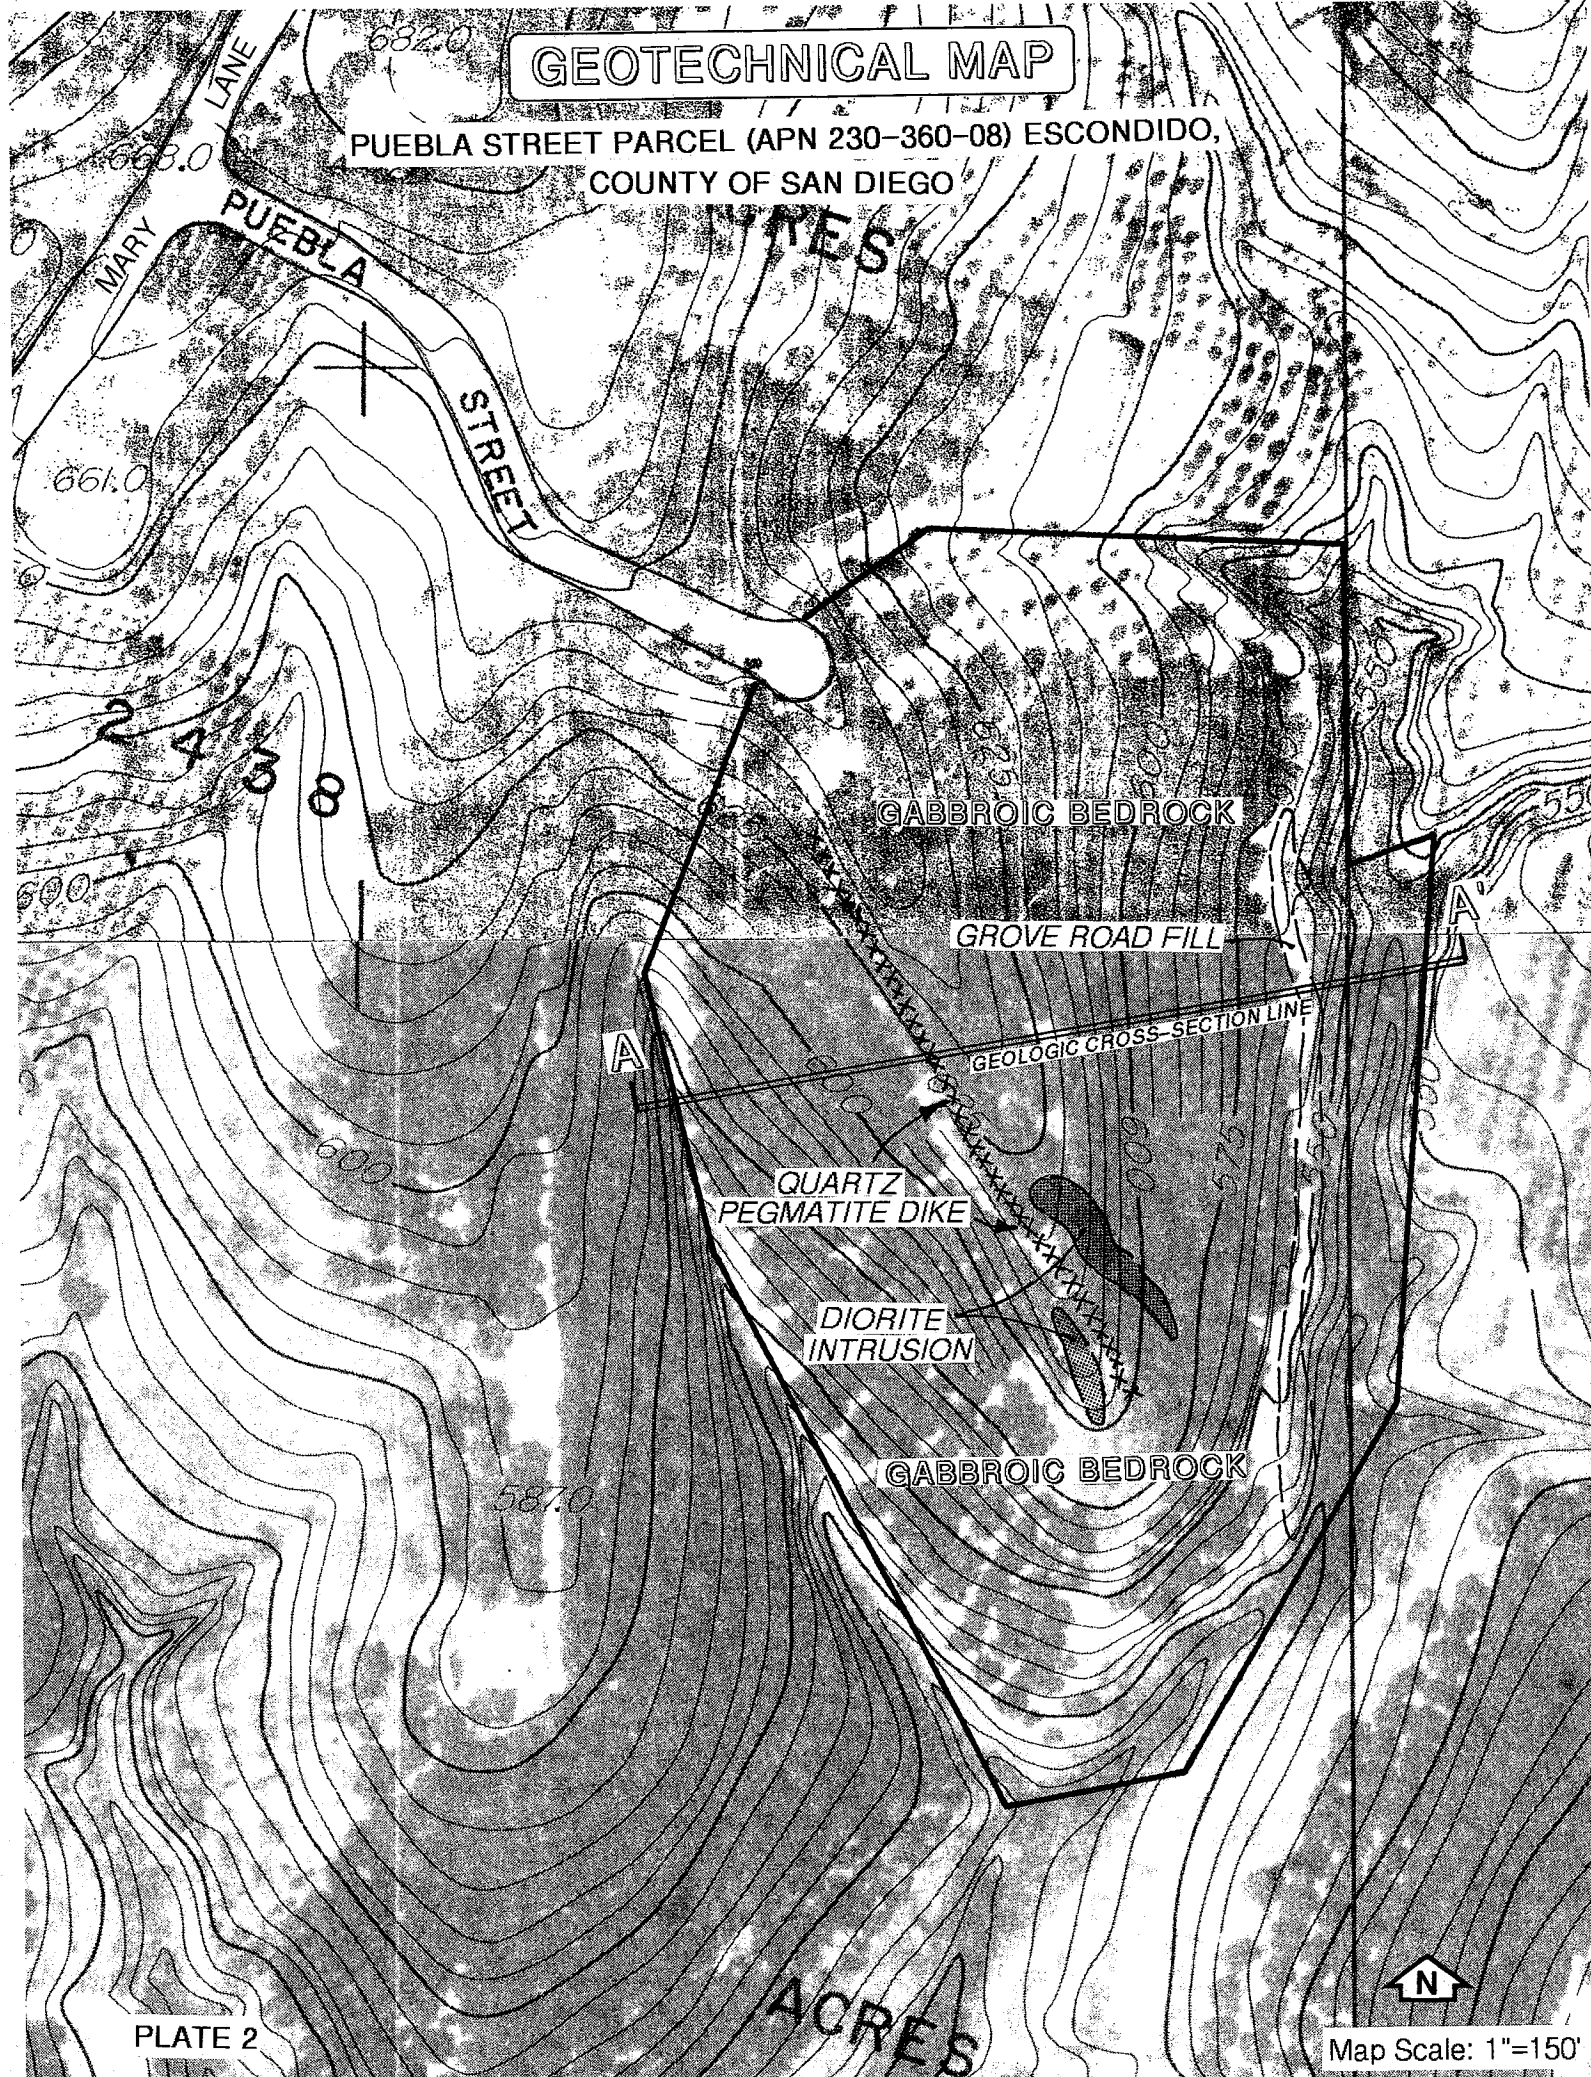
GEOTECHNICAL MAP

Details of site topographic conditions are shown on a Geotechnical Map enclosed with this report as Plate 2. The property is dominated by natural north-south trending ridge terrain. Irregular slopes descend into south-draining canyons to the east and west at gradients that approach 2:1 (horizontal to vertical) at their steepest, overall. Locally steeper conditions are associated with hard rock outcrops and an old graded roadway along the east margin. The roadway provided access to the lower reaches of the property in support of previous orchard activities. Presently, upper surface areas of the site support a light cover of native grasses and some small trees. Recent clearing of the upper reaches of the property near Puebla Street have exposed surface soils.

Secondary intrusive rocks also occur at the site in prominent surface outcrops approximately as shown on Plate 2. A notable white colored quartz pegmatite extends across the upper reaches of the site and forms a tabular-shaped 3-5 foot thick dike structure. A second intrusion of quartz-bearing diorite is also present as shown. These rocks are characterized by a distinctive black color and are extremely hard.

approximately as shown on Plate 2. The exposures indicate that the rocks occur in tabular-shape dikes that are generally oriented north-south and dip to the east at a moderate to steep angle.

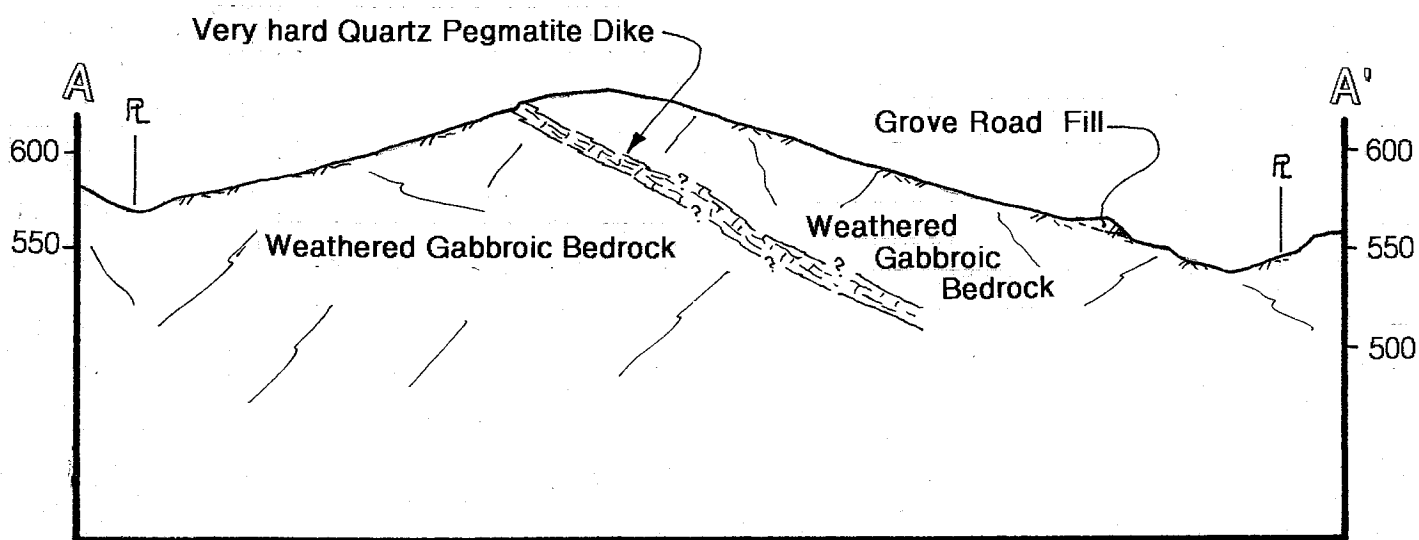
PLATE 3

The indicated subsurface distribution of earth materials at the project site is shown on a Geologic Cross-Section enclosed with this report as Plate 3.
